Aquatic Park Amphitheater Focused Historic Structure Report

San Francisco Martime National Historical Park San Francisco, California

Architectural Resources Group Architects, Planners & Conservators, Inc.

20 June 2005

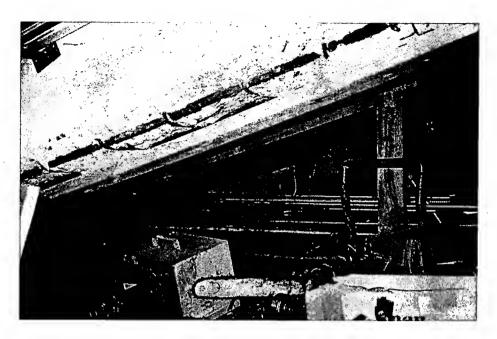
Figure 3: Detail of spalled concrete below east bleacher. Photo dated March 2005 by ARG.

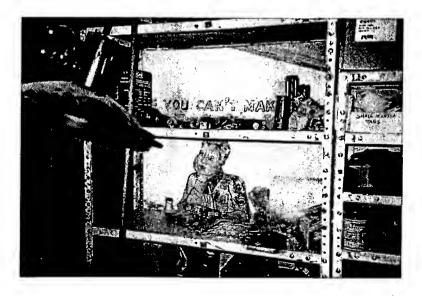
Figure 4: View of small painted wall mural beneath the east bleacher executed by an unknown military artist sometime during the period that the Aquatic Park bathhouse was turned over for military uses of housing troops and as offices. Mural dated circa 1940s. Photo dated March 2005 by ARG.

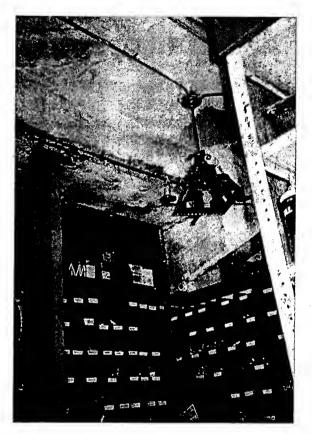
Figure 8: View of evidence of water infiltration and exposed rebar on the plaster ceiling surfaces in the storage area off the NPS offices, east bleacher. Photo dated March 2005 by ARG.

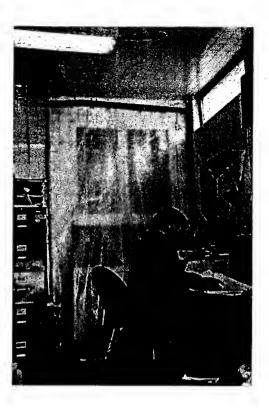
Figure 10: Water infiltration in the NPS offices, east bleacher, has damaged cabinetry. Photo dated March 2005 by ARG.

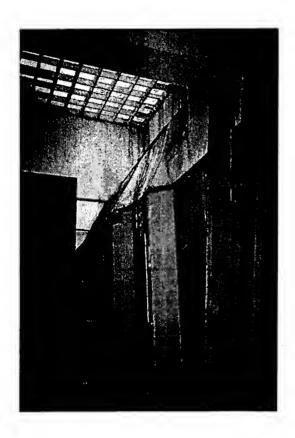
Figure 12: View of tiled surfaces of former men's shower, now used as storage. Note staining from arrested water infiltration in the area of the skylights, east end of central bleacher, looking west. Photo dated March 2005 by ARG.

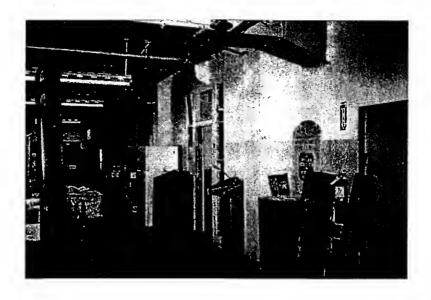
Figure 14: View of passage below central bleacher, looking east. Photo dated March 2005 by ARG.

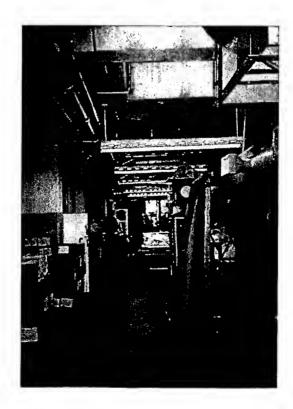
Figure 15: View of passage below central bleacher, looking west. Photo dated March 2005 by ARG.
